PIPEREPLACEMENT

LESS IS MORE IN OREGON

Static pipe bursting solves complex pipe replacement challenges with little disturbance

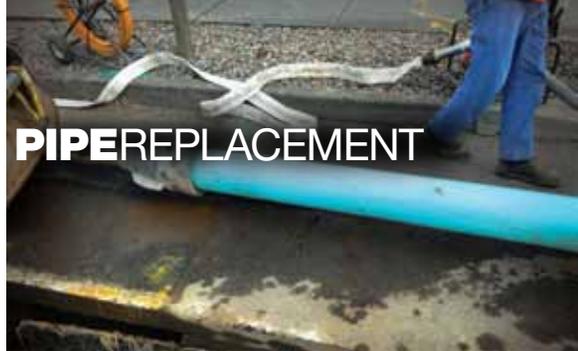
Clean Water Services decided to replace an aging portion of concrete sanitary sewer main in Beaverton, Ore., that was experiencing excessive tree root infiltration.

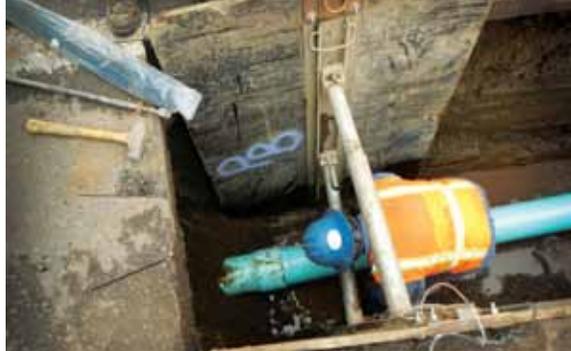
The pipe replacement presented some challenges due to tight space limitations.

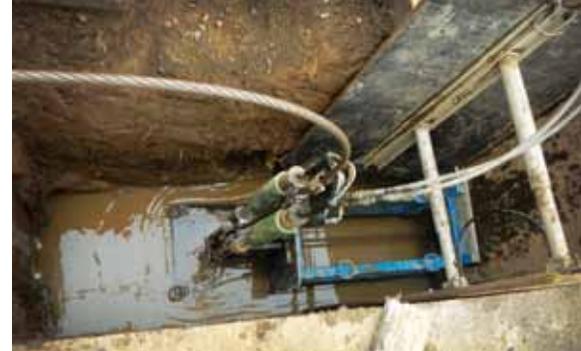
Static pipe bursting was the best way to complete the project with the least disturbance to the surrounding area.
